Manhole Inspection Summary

Manhole # S17GG1002MH

Insp Date: **1/8/07 1:44 PM**

Location Address: **4026 GREENSPRING AVE**

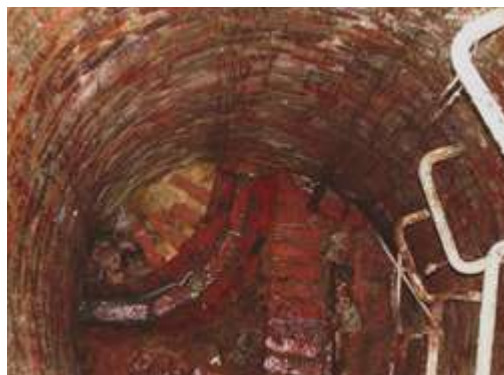
Top View

Corroded steps. Bench debris.

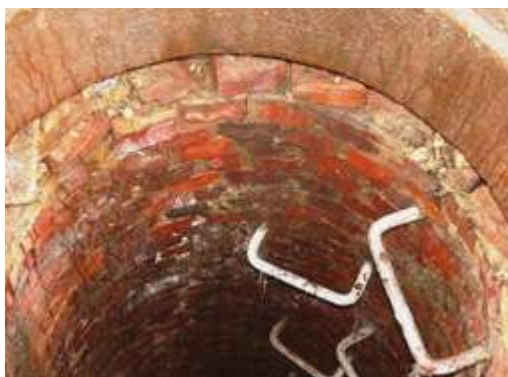
Defect

Frame leaks. Adjustment deterioration and infiltration - other side.

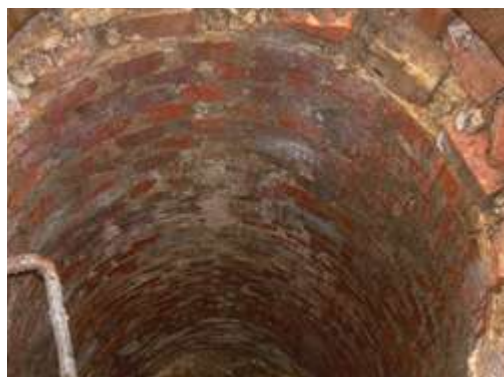
Defect

Adjustment deterioration, loose brick, and infiltration. Barrel infiltration.

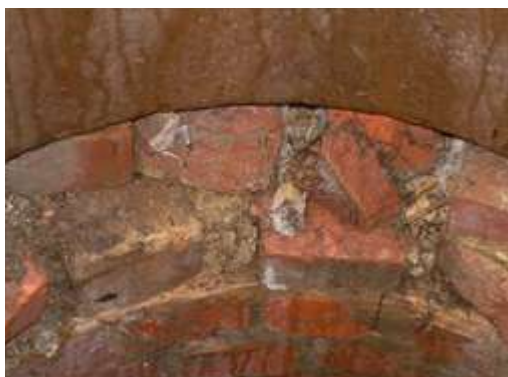
Defect

Frame leaks. Adjustment deterioration and infiltration.

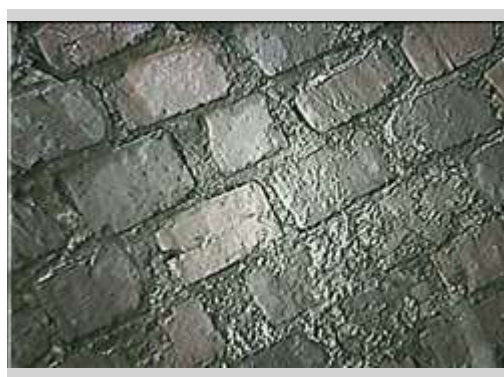
Defect

Adjustment infiltration.

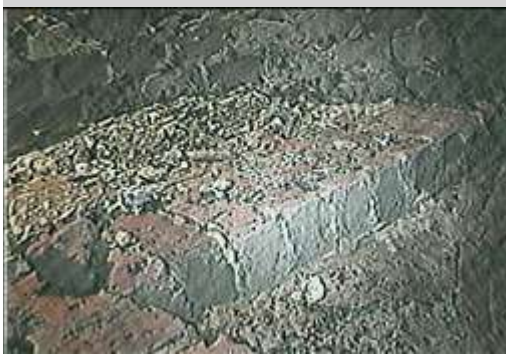
Defect

Bench debris.
